**Reference** one family house - heating system  
**Project** Installation of the Flowjet to increase efficiency

**Results approximately 18 months after commissioning the Flowjet in the heating system:**

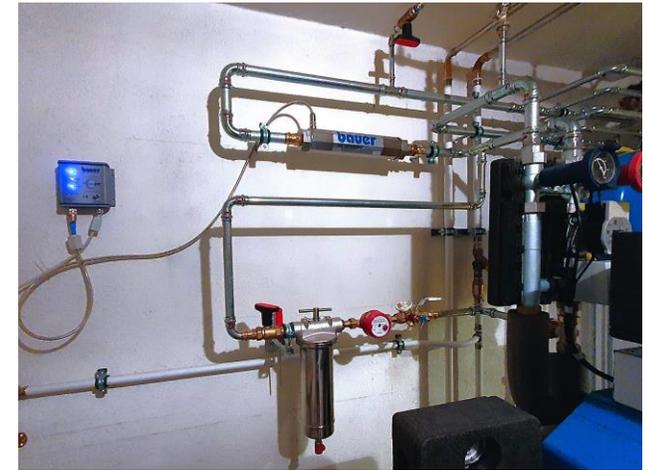
Contaminants from the heating water and deposits in the heating system (radiators, pumps, pipes, valves) as waste products from chemical reactions, sediments, rust particles and sludge, are removed from the system walls using the Flowjet and reliably eliminated from the system thanks to the connected cartridge filter.

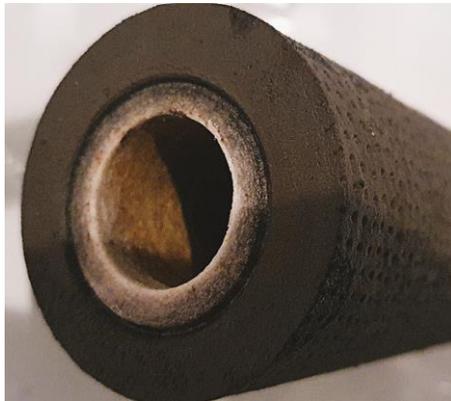
First cartridge replacement:  
Some impurities were filtered out. The amount of dirt is not particularly high.

Image on the right: Cartridge with initial dirt load. The removal process has just begun.

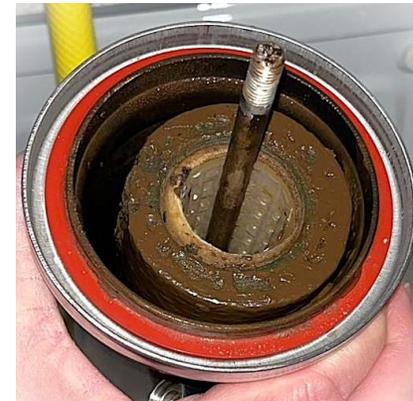
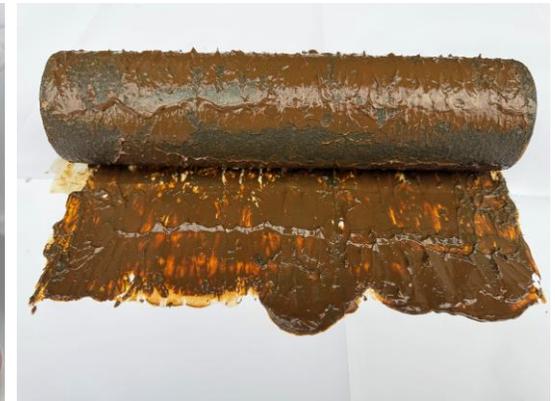
Second cartridge replacement:  
More dirt was removed. Deposits are increasingly being loosened by the Flowjet.

Images on the right: Top view of the filter and the filter surface. Enormous amount of dirt consisting of deposits and sediments from the heating system.
